**SAUGUS RIVER BASIN  
SAUGUS, MASSACHUSETTS**

**GRISWOLD POND DAM  
MA 00292**

# **PHASE I INSPECTION REPORT NATIONAL DAM INSPECTION PROGRAM**

**OCTOBER 1979**

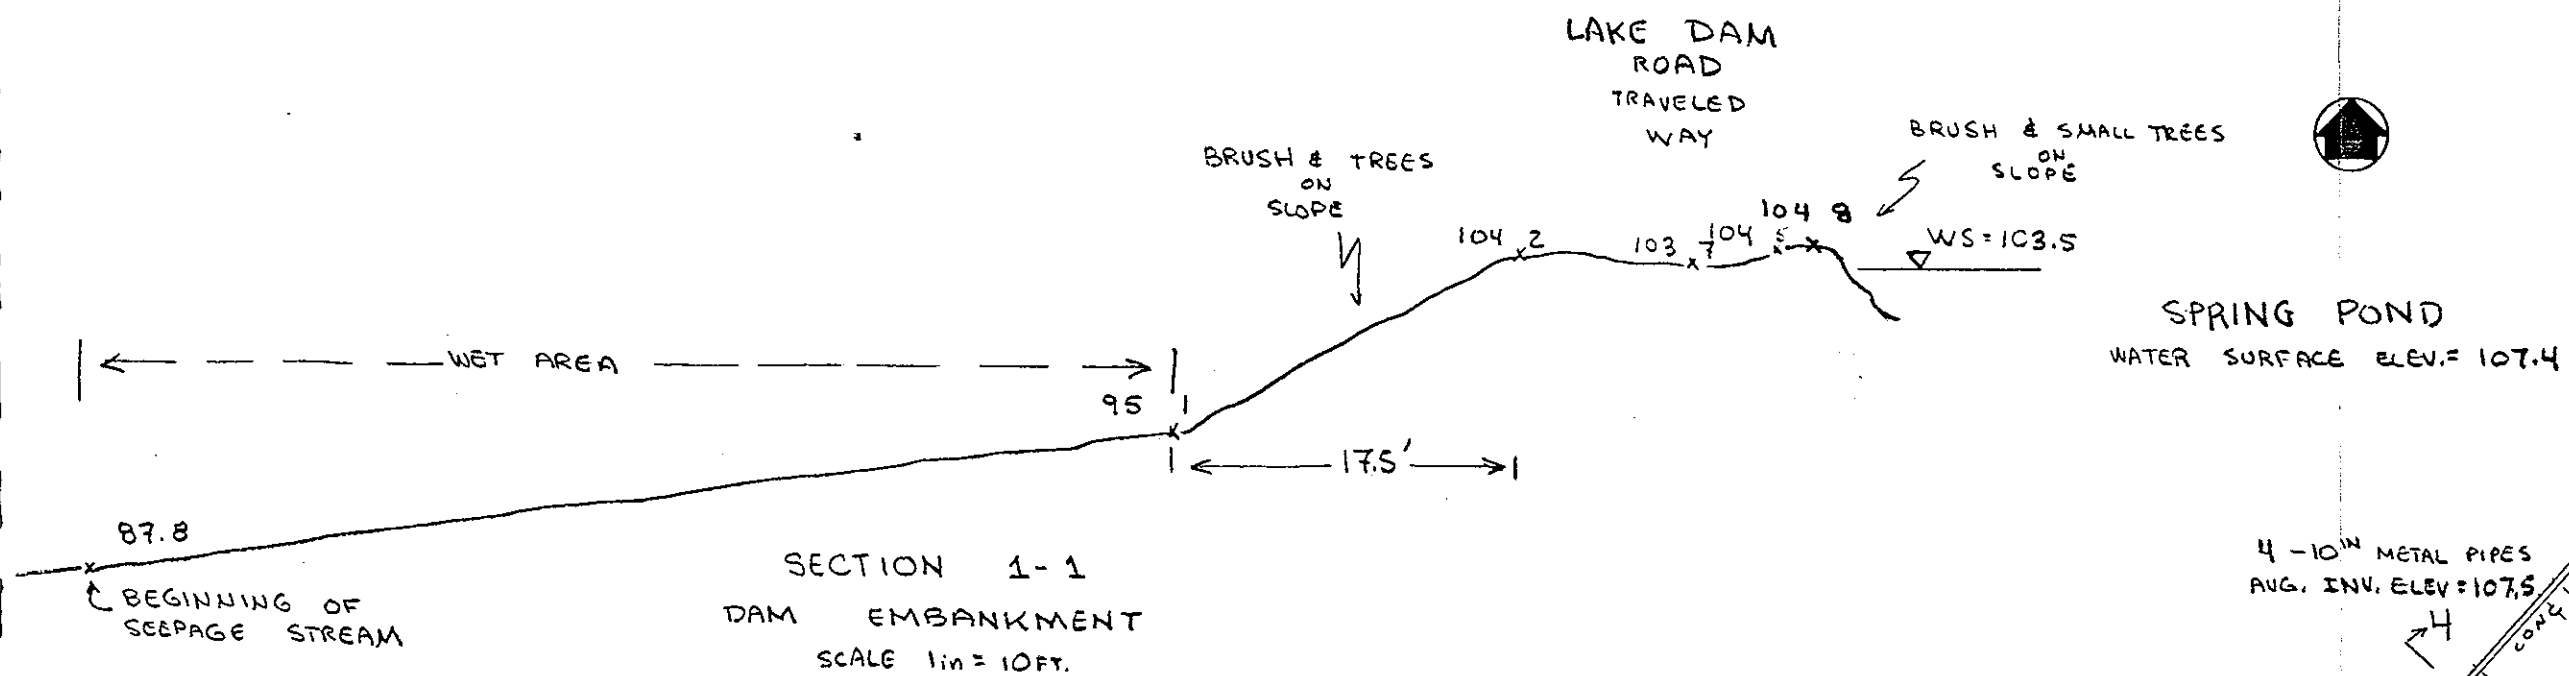
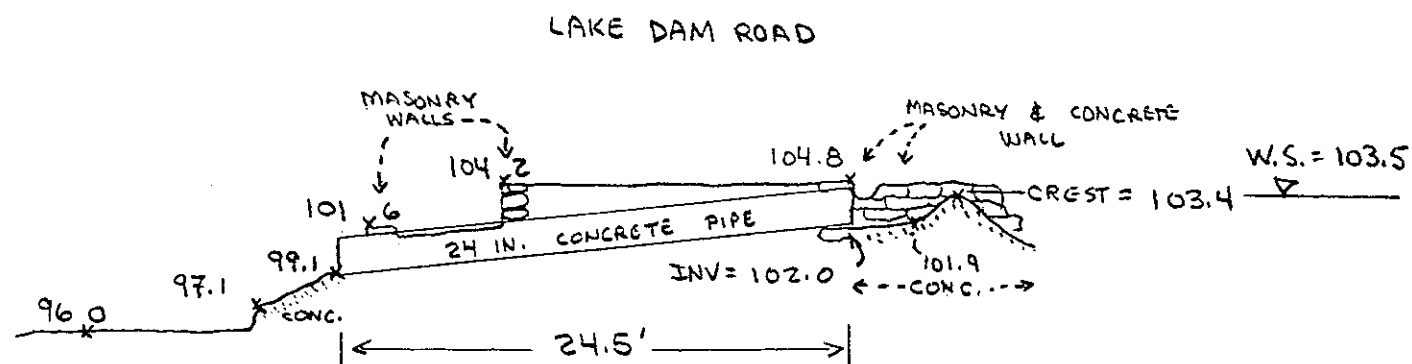
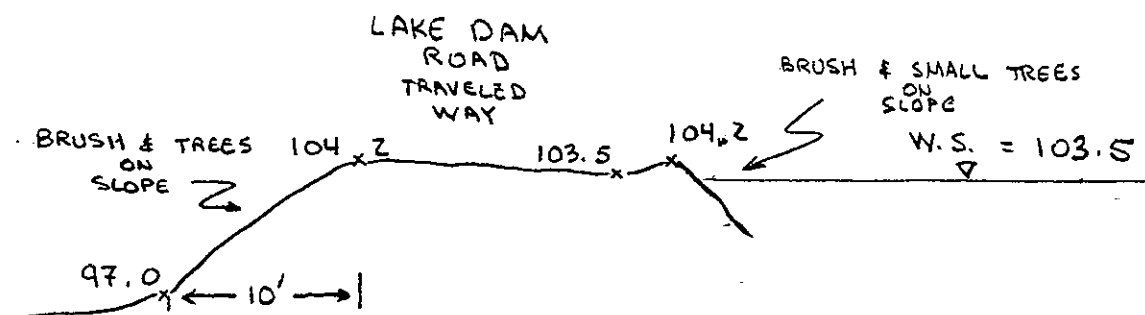
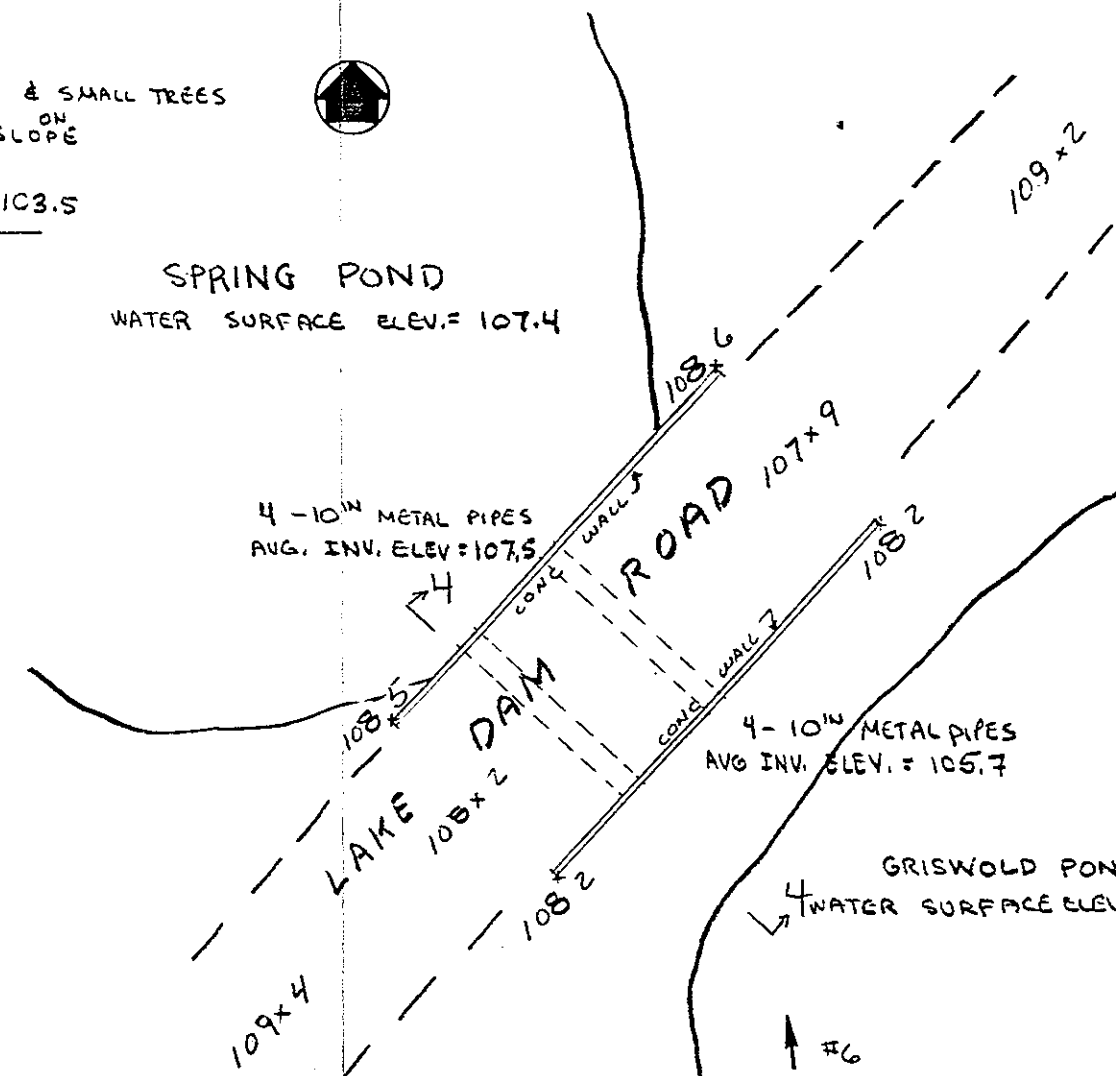
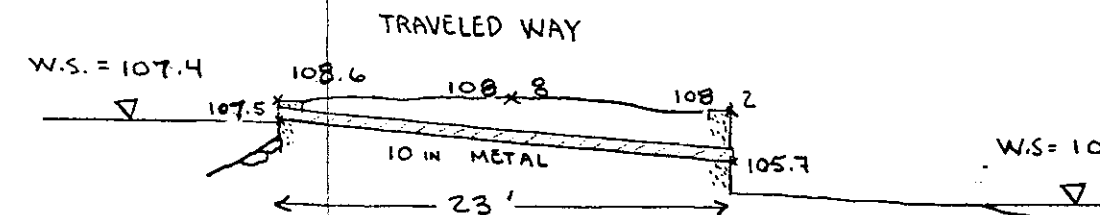
METCALF & EDDY, INC. ENGINEERS BOSTON, MA.	U.S. ARMY ENGINEER DIV. NEW ENGLAND CORPS OF ENGINEERS WALTHAM, MA.
NATIONAL PROGRAM OF INSPECTION OF NON-FED. DAM	
GRISWOLD POND DAM	
FIGURE B-2 ADDITIONAL DETAILS AND SECTIONS	
TRIBUTARY SAUGUS RIVER	MASSACHUSETTS
SCALE: AS SHOWN	DATE: APRIL, 1979

SECTION 3-3  
DAM EMBANKMENT  
SCALE 1 in = 10 ft.
